Inspector's Daily Report

IDR Sheet	1	of 1	Sheets	Final Record Book	Page
Contract			Day		Date
C-7852			Thursday		June 30, 2011

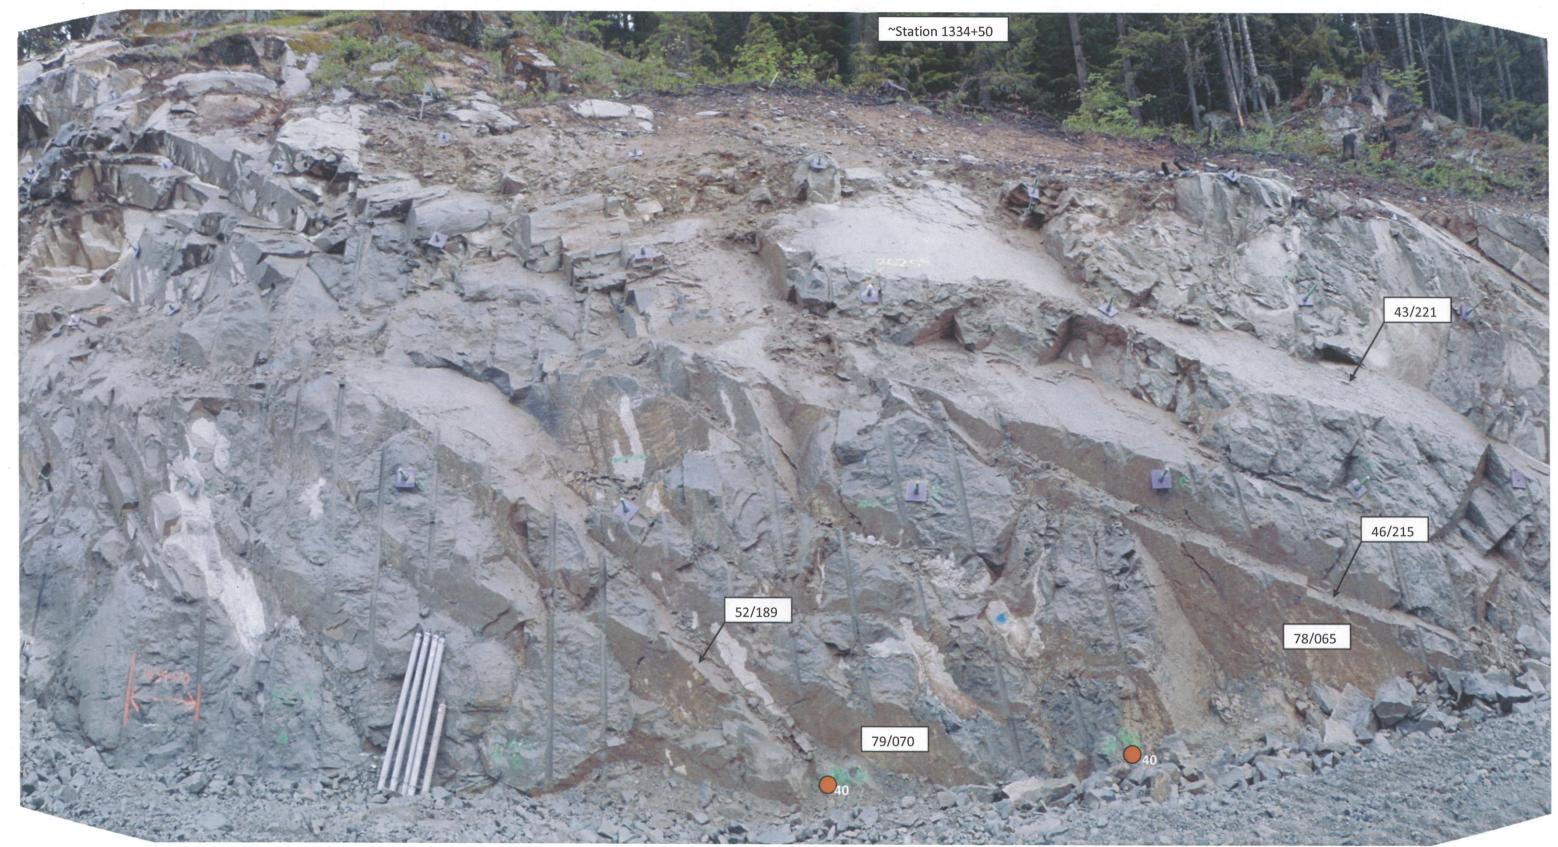
Figure 1. A photograph showing the Type H rock dowel lay out at approximate station 1334+50.

Type H Rock Dowel (Minimum Length in Feet)

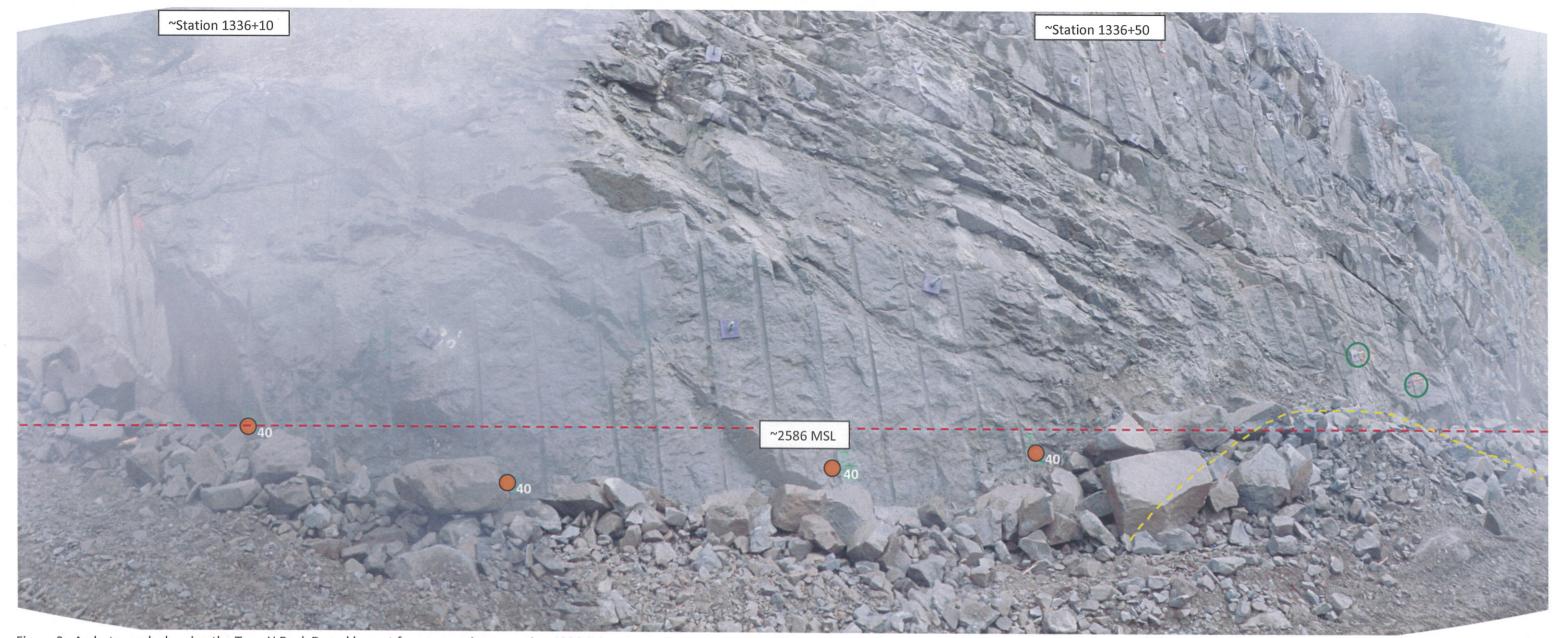
I arrived at the Hyak office around 7:30 am to finish my IDR from the previous shift. I drove to the east side of the project to meet with Brad Schut. Brad indicated that there were a few pattern dowels that we could locate around the Jenkin's Knob area. Brad and I walked up to Jenkin's Knob and located two 40-foot Type H rock dowels around station 1334+50 (Figure 1) and four 40-foot pattern Type H rock dowels from approximate station 1336+10 to 1336+50 at approximate elevation 2586 MSL (Figure 2). Brad and I attempted to tie these four rock dowels into the pattern Type H dowels that were installed in 2010 (Figure 2). Two more Type H rock dowels need to be located between what we located today and the dowels that were installed in 2010; however, there is a hard toe that needs to be removed before they are located (Figure 2).

Figure 2. A photograph showing the Type H Rock Dowel lay out from approximate station 1336+10 to 1336+50 at approximate elevation 2586. Note the hard toe located around station 1336+75 from 2010 (Yellow Dashed Line).

40 Type H Rock Dowel (Minimum Length in Feet)

Type H Rock Dowels installed in 2010

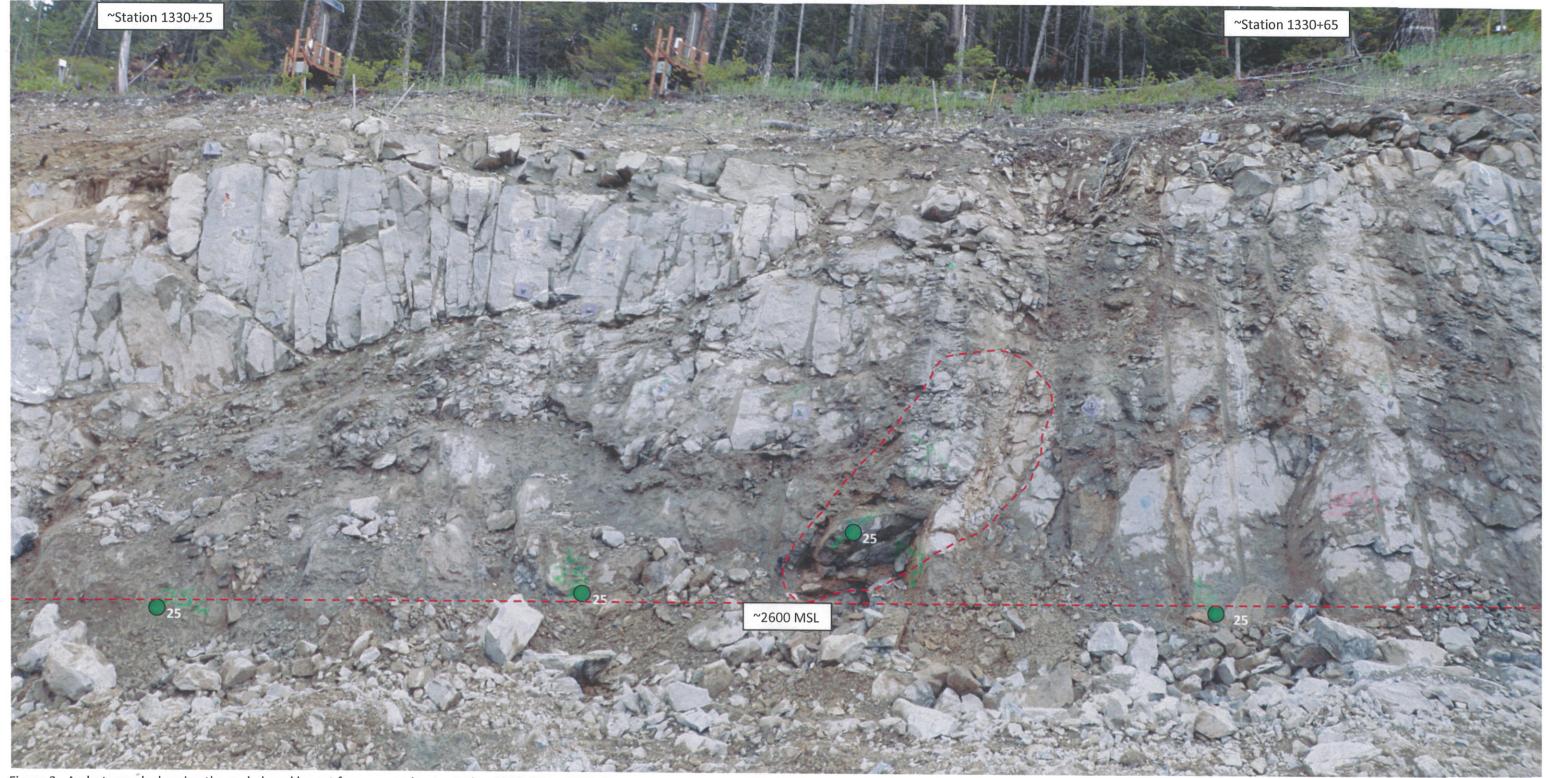
I drove to the east side of the project around 1:30 pm and met with Chris Beehler (WSDOT Inspector). We walked to approximate station 1330+25 to 1330+65 and located four 25-foot Type L rock dowels at approximate elevation 2600 MSL (Figure 2). We also located a scaling and dressing area. If the contractor is unable to remove the rock blocks, then the pattern dowel should be moved up and installed in the overhung rock block (Figure 3).

Figure 3. A photograph showing the rock dowel layout from approximate station 1330+25 to 1330+65 at approximate elevation 2600 MSL.

25 Type L Rock Dowel (Minimum Length in Feet)
